• PROTECTING INLAND LAKES THROUGH NATURAL SHORELINES

An Introductory Guide to Bioengineering Techniques

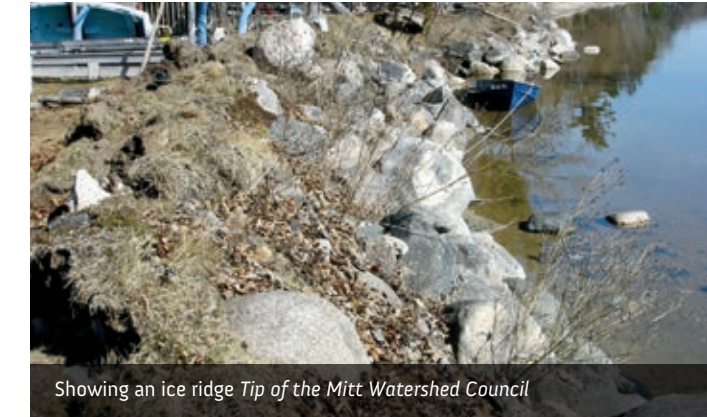
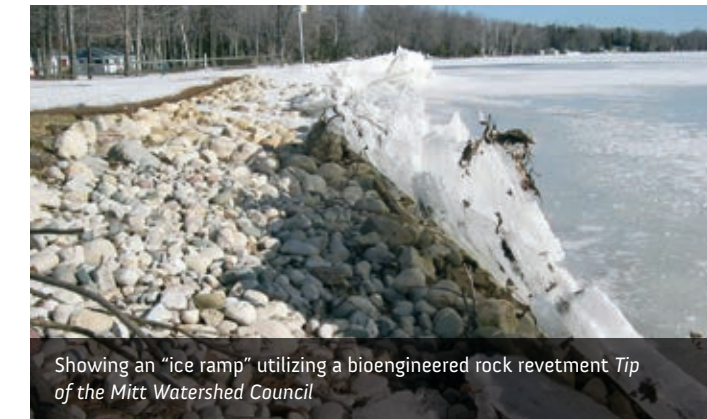
DEPICTION OF ICE STRENGTH

Figures 2A and 2B: Showing ice push and break up along a shoreline.

- Ice is the strongest as it moves horizontally toward a shoreline. It can exert 10-12 tons per square foot of pressure on our shorelines. (See Figure 2A)
- Ice becomes weaker as it moves at an angle and even weaker over rough surfaces. (See Figure 2B)

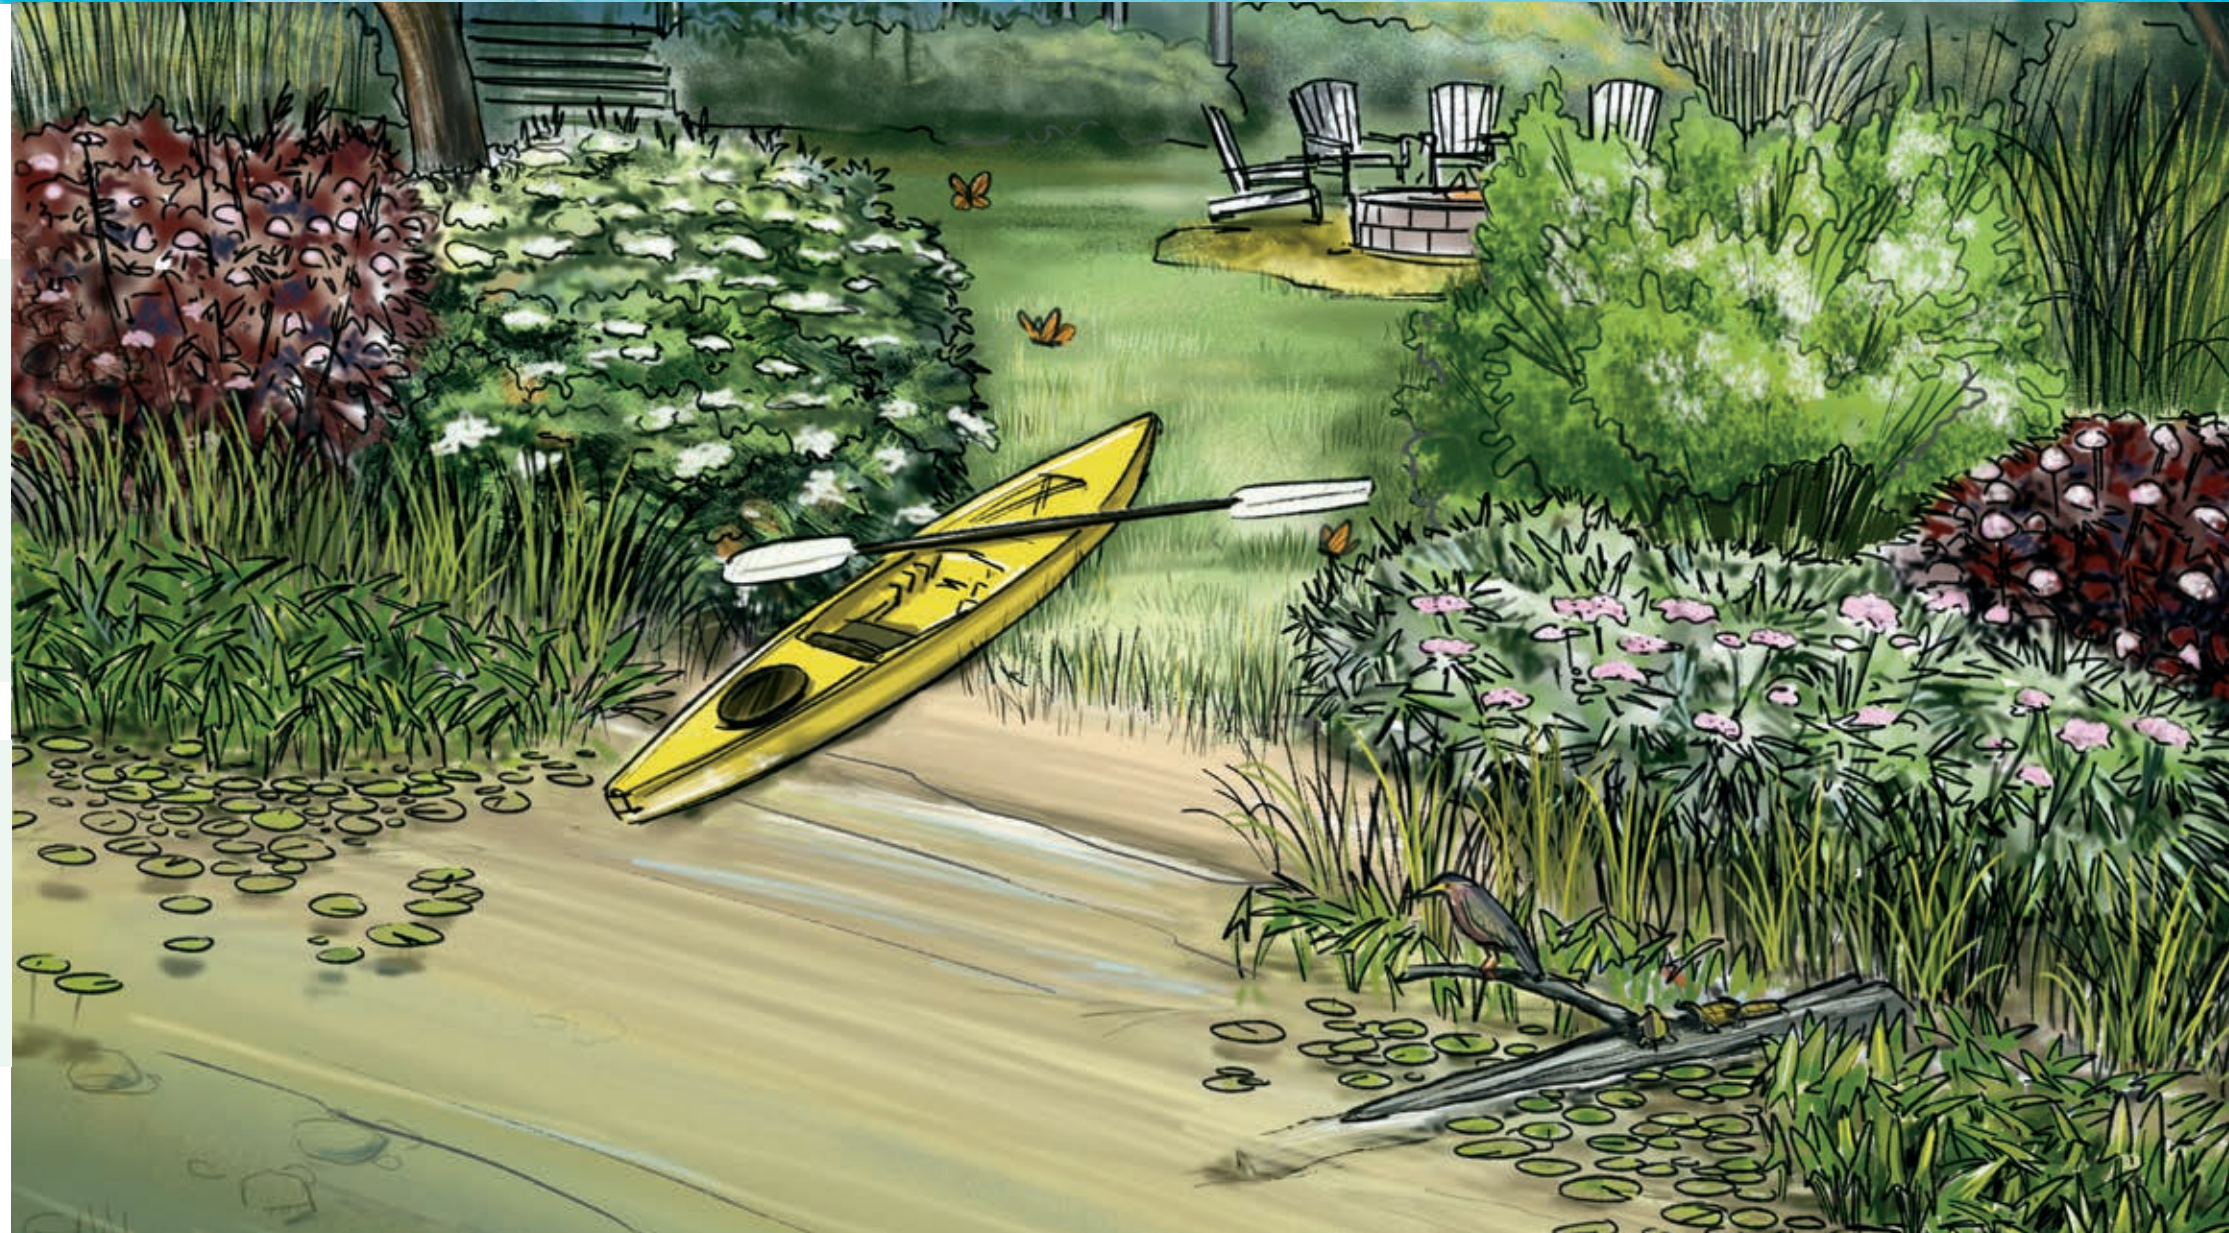
Figure 3: A shoreline balancing recreational access with shoreline habitat and lake health.

Keeping native vegetation both on the land and in the water provides habitat for fish and wildlife. It is also critical for helping to prevent shoreline erosion. (Figure 3)

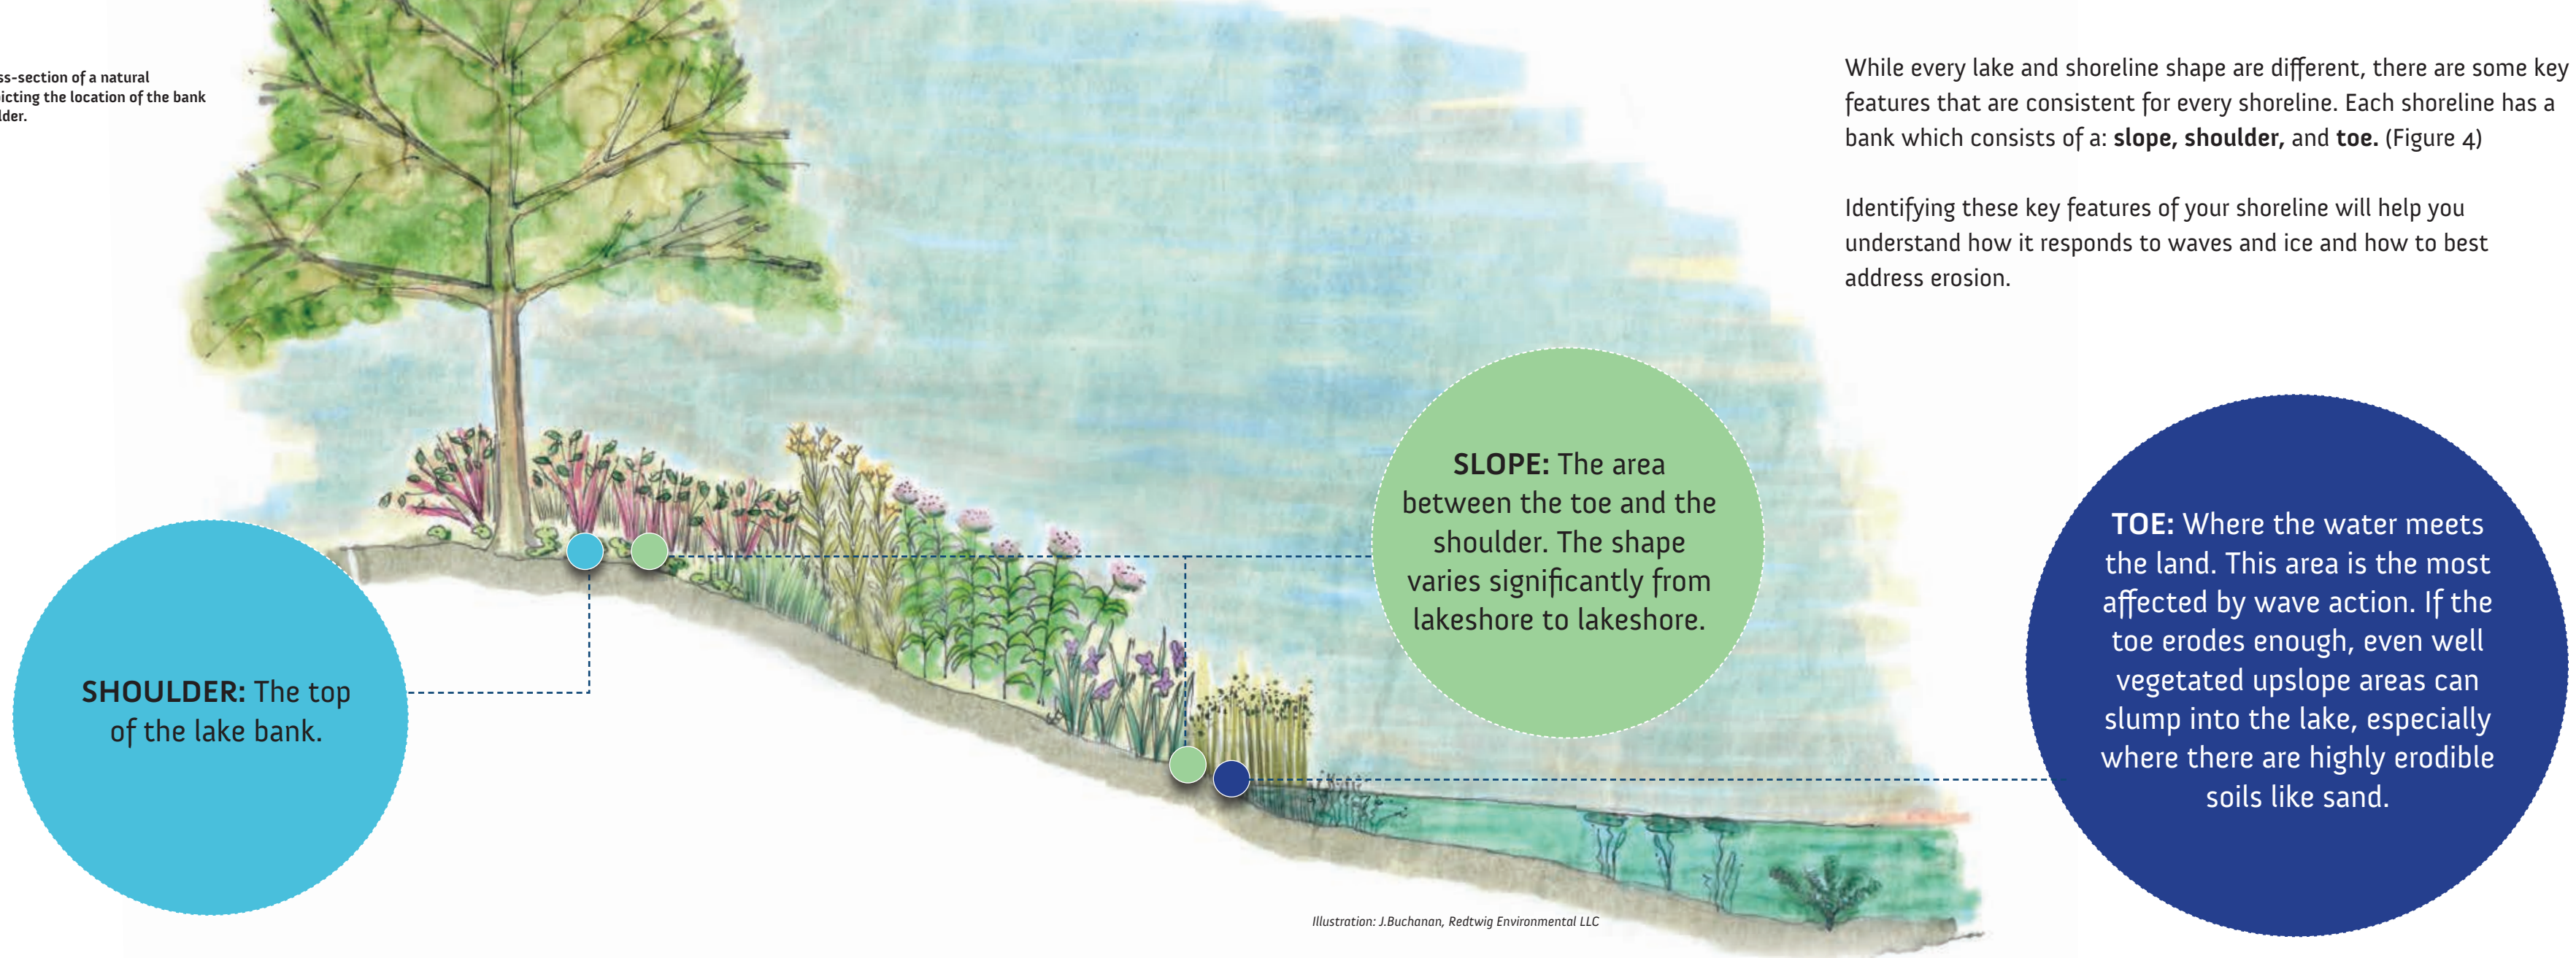
Figure 4: Cross-section of a natural shoreline depicting the location of the bank toe and shoulder.

While every lake and shoreline shape are different, there are some key features that are consistent for every shoreline. Each shoreline has a bank which consists of a: **slope, shoulder, and toe.** (Figure 4)

SHOULDER: The top of the lake bank.

SLOPE: The area between the toe and the shoulder. The shape varies significantly from lakeshore to lakeshore.

TOE: Where the water meets the land. This area is the most affected by wave action. If the toe erodes enough, even well vegetated upslope areas can slump into the lake, especially where there are highly erodible soils like sand.

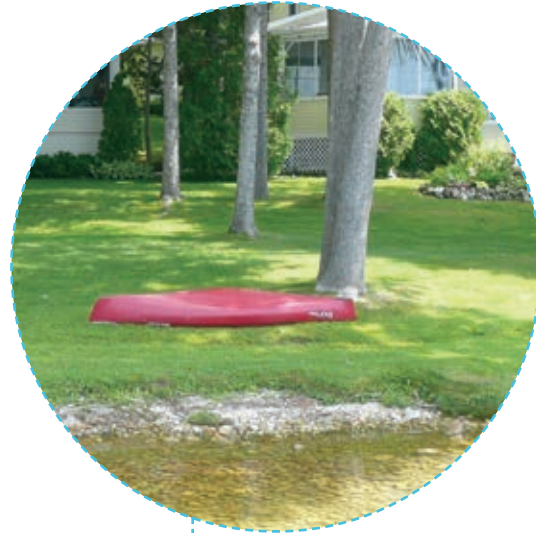
Receding Shoreline:
Shoreline is advancing landward over time.

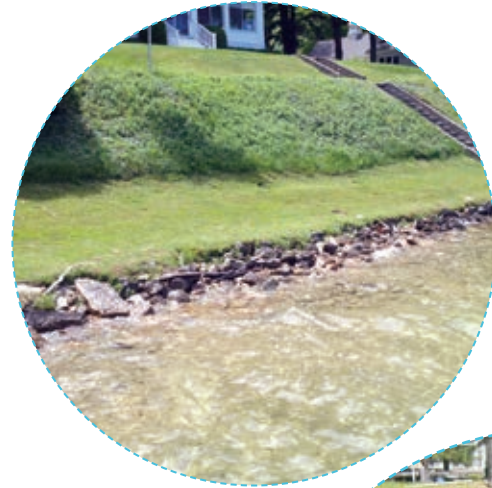
Receding shoreline:
Example where the addition of rock is ineffective due to improper design and lack of shoreline vegetation.

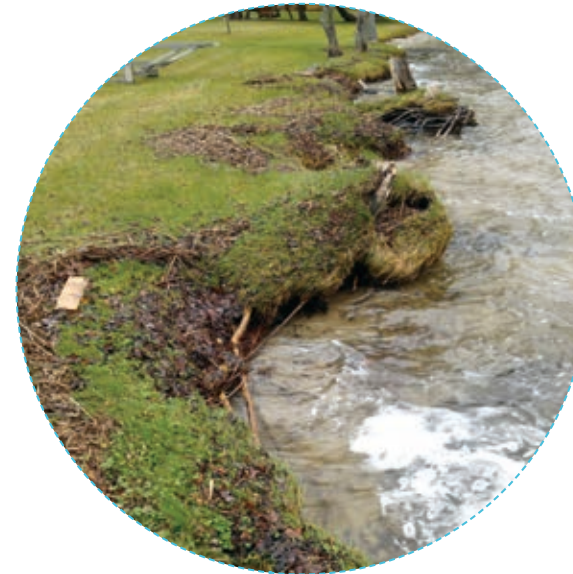
Scalloping:
The irregularities of the shoreline become more pronounced due to exposed shoreline soils. Eventually, the "points" will also erode as residual root structure from the removed vegetation degrades.

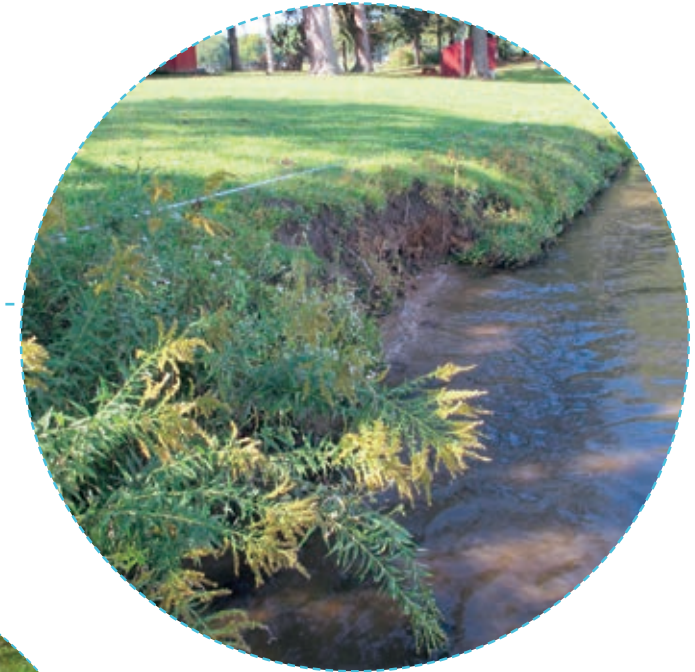
Slumping:
The waves undercut the bank. It then became unstable enough for a portion of it to fall (slump) into the lake.

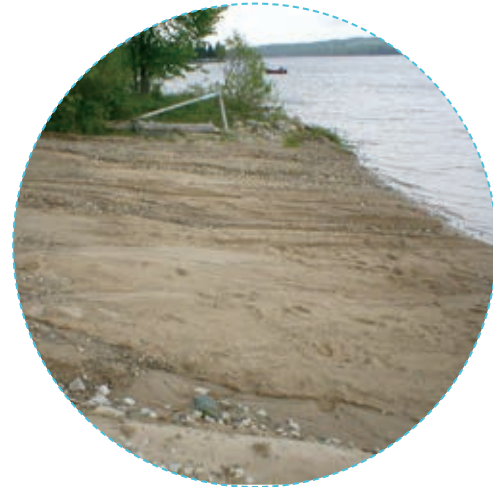
Rills and Gullies:
Channels form from overland runoff due to exposed soil.

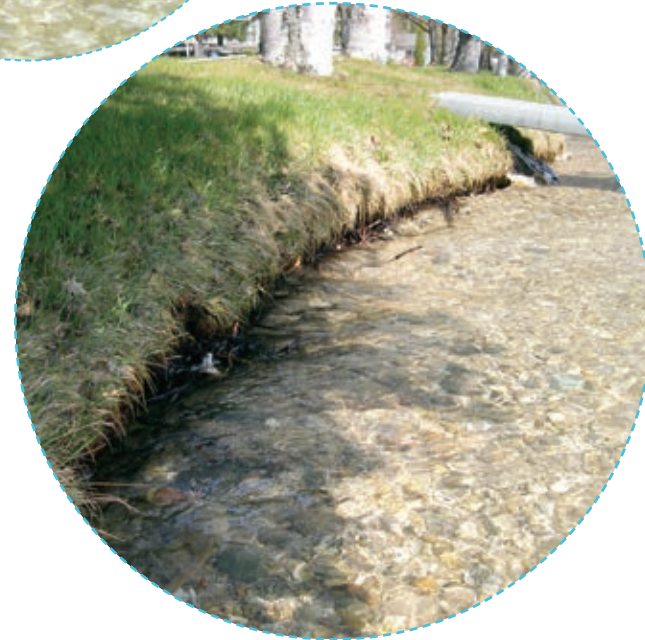
Undercut Bank:
Waves are eroding the soil underneath the bank. Eventually the bank will slump into the lake.

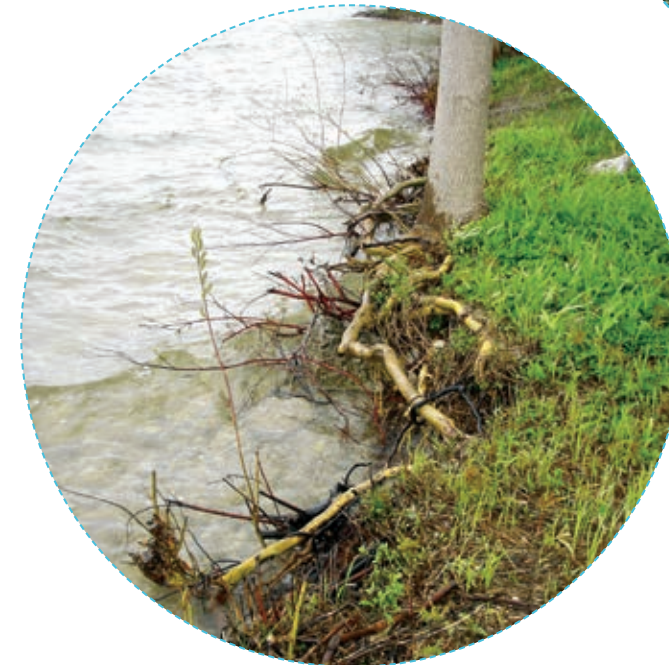
Root Exposure:
It is natural to have some roots exposed along shorelines, however, pronounced root exposure is a sign of accelerated erosion.

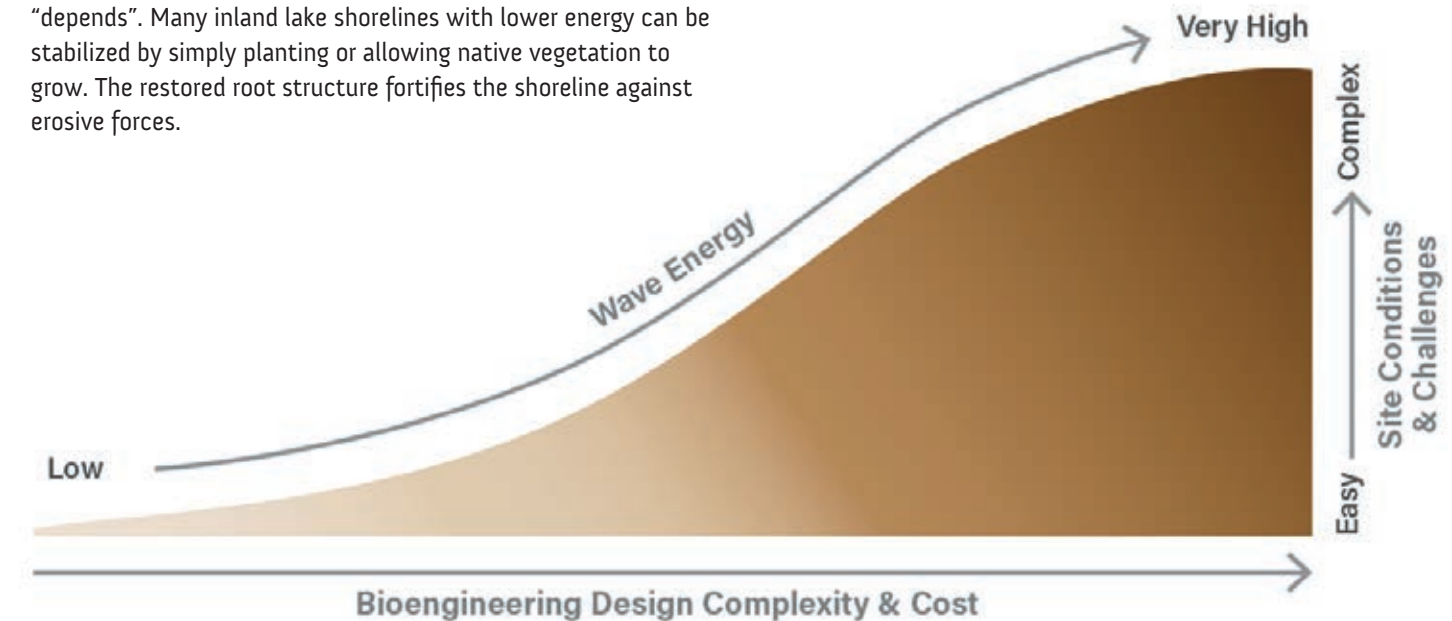
Figure 6: Illustrates the relationships between wave energy, site characteristics and corresponding complexity of bioengineering techniques and costs.

Sites with higher wave energy and more challenging conditions, typically require more complex design solutions and cost more to restore than simple approaches. (See Figure 6)

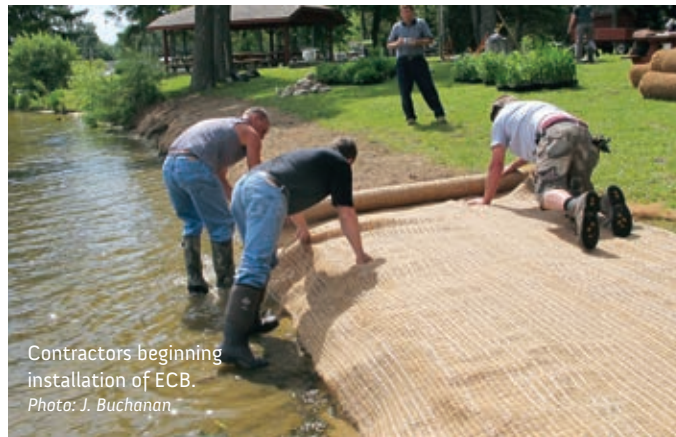
Contractors beginning installation of ECB.
Photo: J. Buchanan

Biodegradable erosion control blankets (ECBs) are used to help stabilize shoreline erosion. ECBs should extend landward the distance needed to cover all exposed soils. Ideally, they should also extend the full depth of the planting area to help with weed control and establishment of new plantings. Once they are properly staked, ECBs may be cut to allow installation of plants through the fabric.

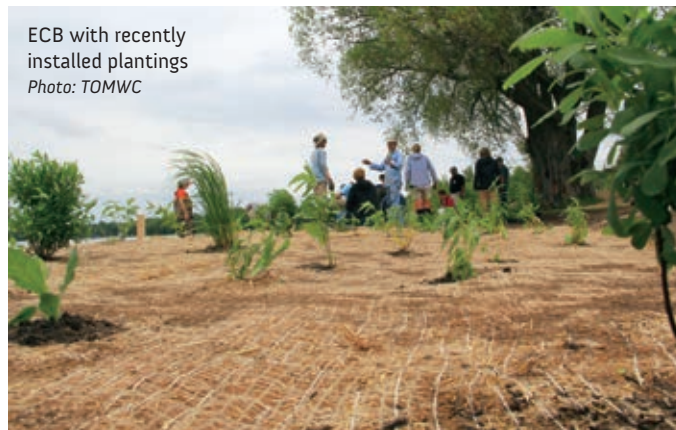
ECB with recently installed plantings
Photo: TOMWC

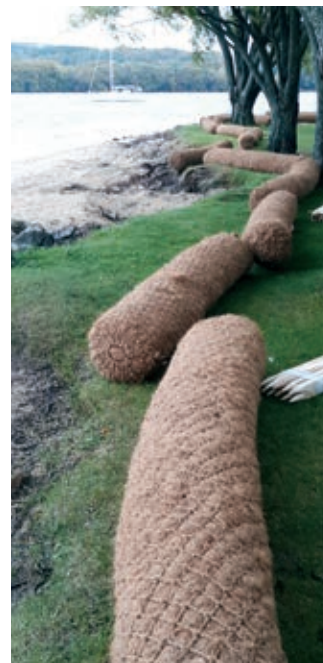
Coir logs staged along shoreline prior to installation.
Photo: J. Buchanan

Biodegradable coir (coconut fiber) logs are held together with other biodegradable materials such as jute twine, and come in a variety of lengths, sizes, and densities. They are used in many applications, most often at the toe of the shoreline, to provide stabilization and promote the development of vegetation. Coir logs provide long-term, yet temporary, protection. As plant roots grow into and through the logs they biodegrade yielding a more resilient shoreline. When conditions allow, plantings can be installed directly into the coir logs, but extra care is then needed to ensure their survivability.

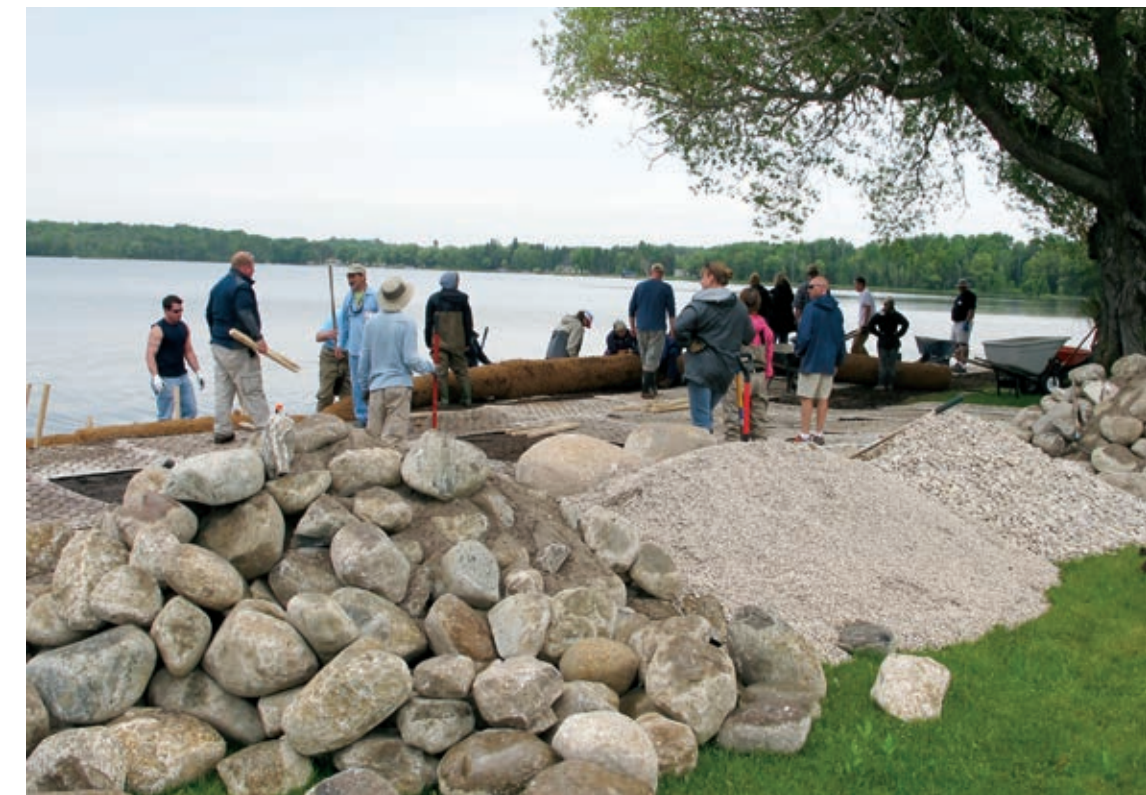
Fieldstone, drain stone, and pea gravel staged prior to installation on a high energy lake.
Photo: J. Buchanan

Many bioengineering projects require the use of rock to help provide stability and resiliency against erosive forces. Whether to use rock or not depends on the site conditions. Rounded fieldstone is recommended over other types of rock, such as angular quarried rock, because it creates a more flexible and resilient system. A mixture of rock sizes is required and the size is determined by the wave height and design. The different sizes of rock act like ball bearings to allow the rock to flex and settle more easily.

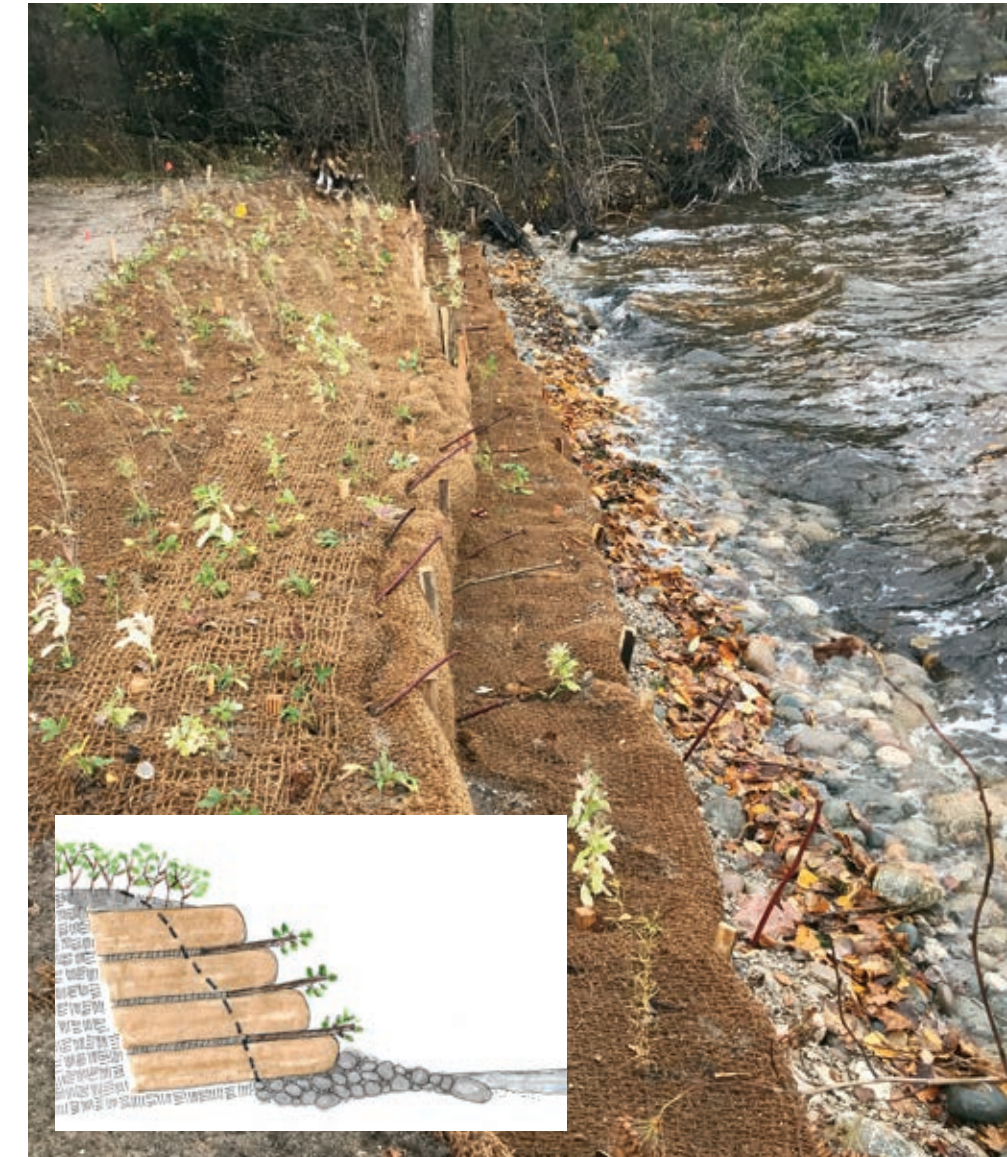
Figure 9: An encapsulated soil lift design and installation.
Photo: TOMWC

Encapsulated soil lifts, sometimes called vegetated geogrids, are layers of soil “encapsulated” inside biodegradable fabric to form the lift and are built on a rock base (See Figure 9). The rock base is sized and sloped correctly per site conditions. Each lift (or layer) is placed on top of the preceding lift, but stepped back to create the desired slope. They are then planted with native plants. Banks typically need to be pulled back to create the desired slope.

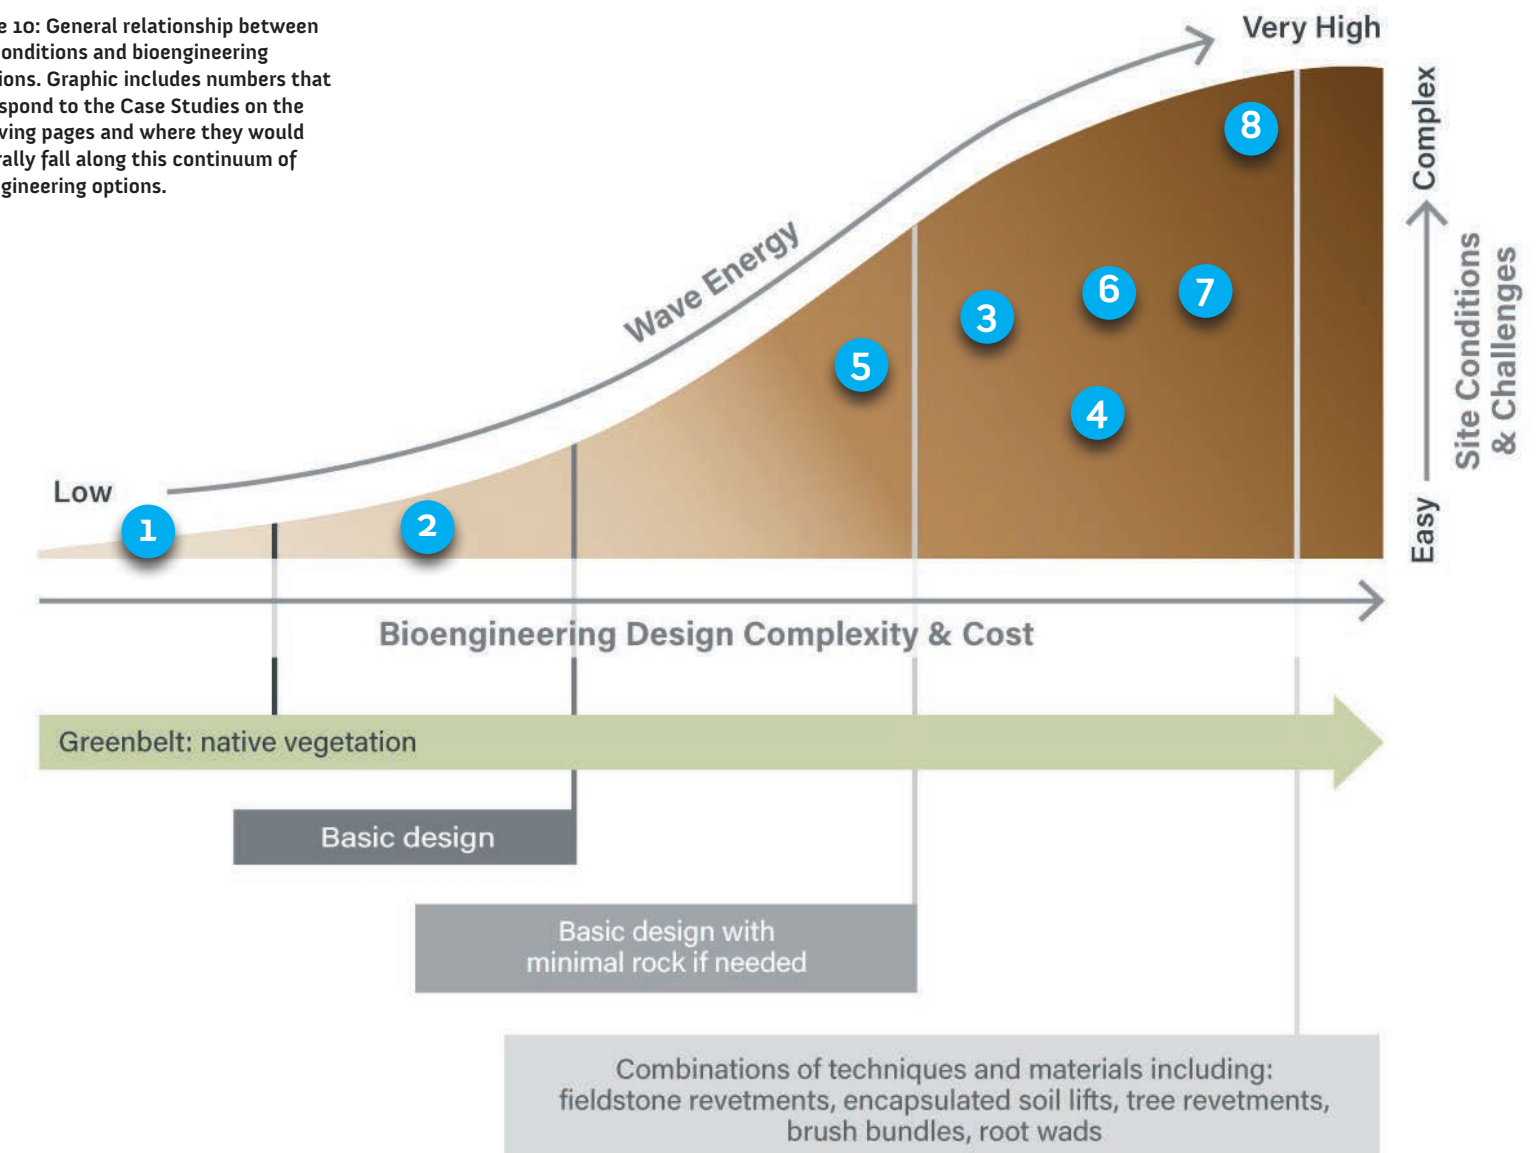
Figure 10: General relationship between site conditions and bioengineering solutions. Graphic includes numbers that correspond to the Case Studies on the following pages and where they would generally fall along this continuum of bioengineering options.

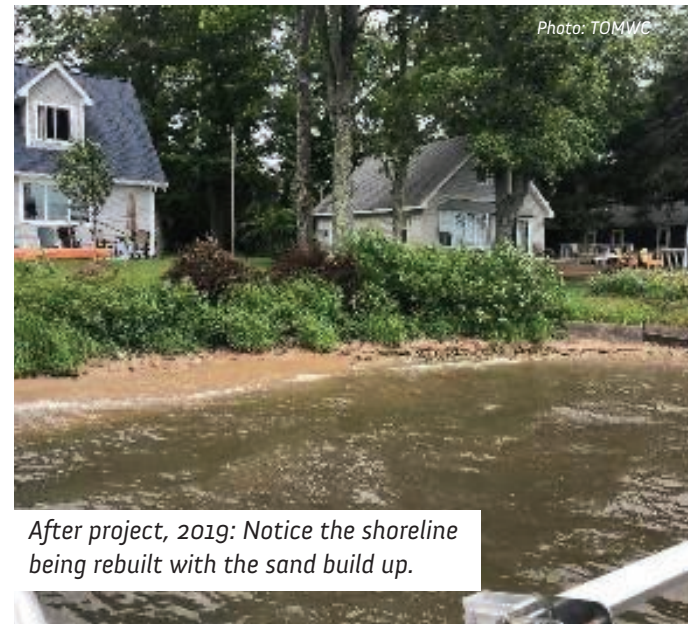
After project, 2019: Notice the shoreline being rebuilt with the sand build up.

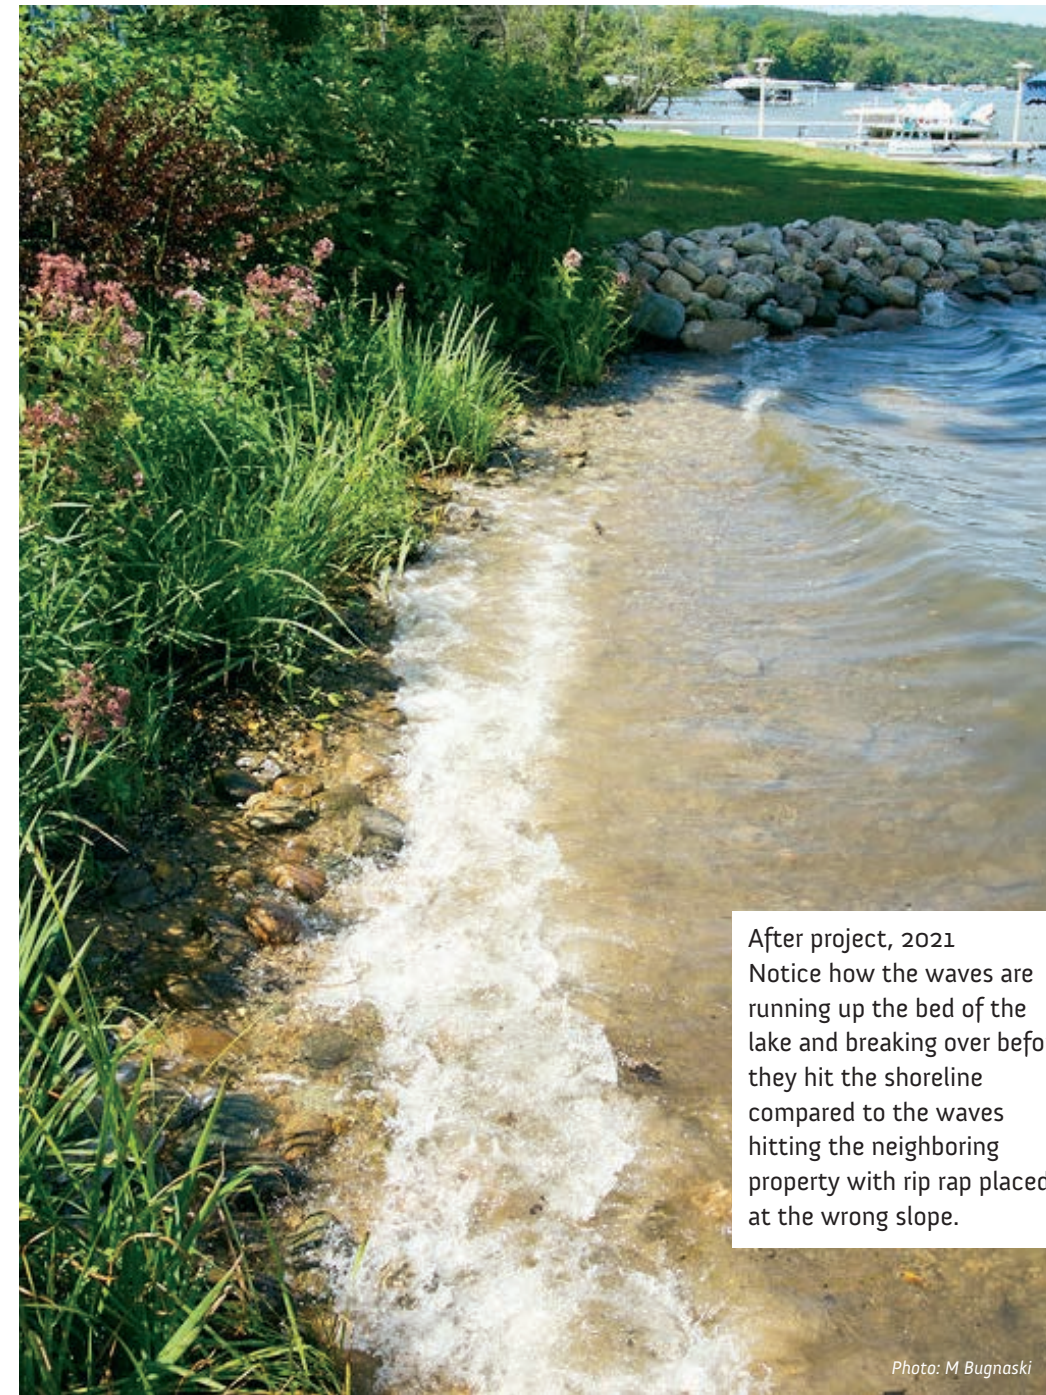
After project, 2021
Notice how the waves are running up the bed of the lake and breaking over before they hit the shoreline compared to the waves hitting the neighboring property with rip rap placed at the wrong slope.
